Submitted in Partial Satisfaction of the Requirements for  
the Degree of Master of Engineering

REPAIRS TO CONCRETE  
PORT AND HARBOR STRUCTURES

MAX D. RODGERS  
and  
JAMES M. SCHOFIELD

Hydraulic and Coastal Engineering  
Department of Civil Engineering  
University of California  
Berkeley, California

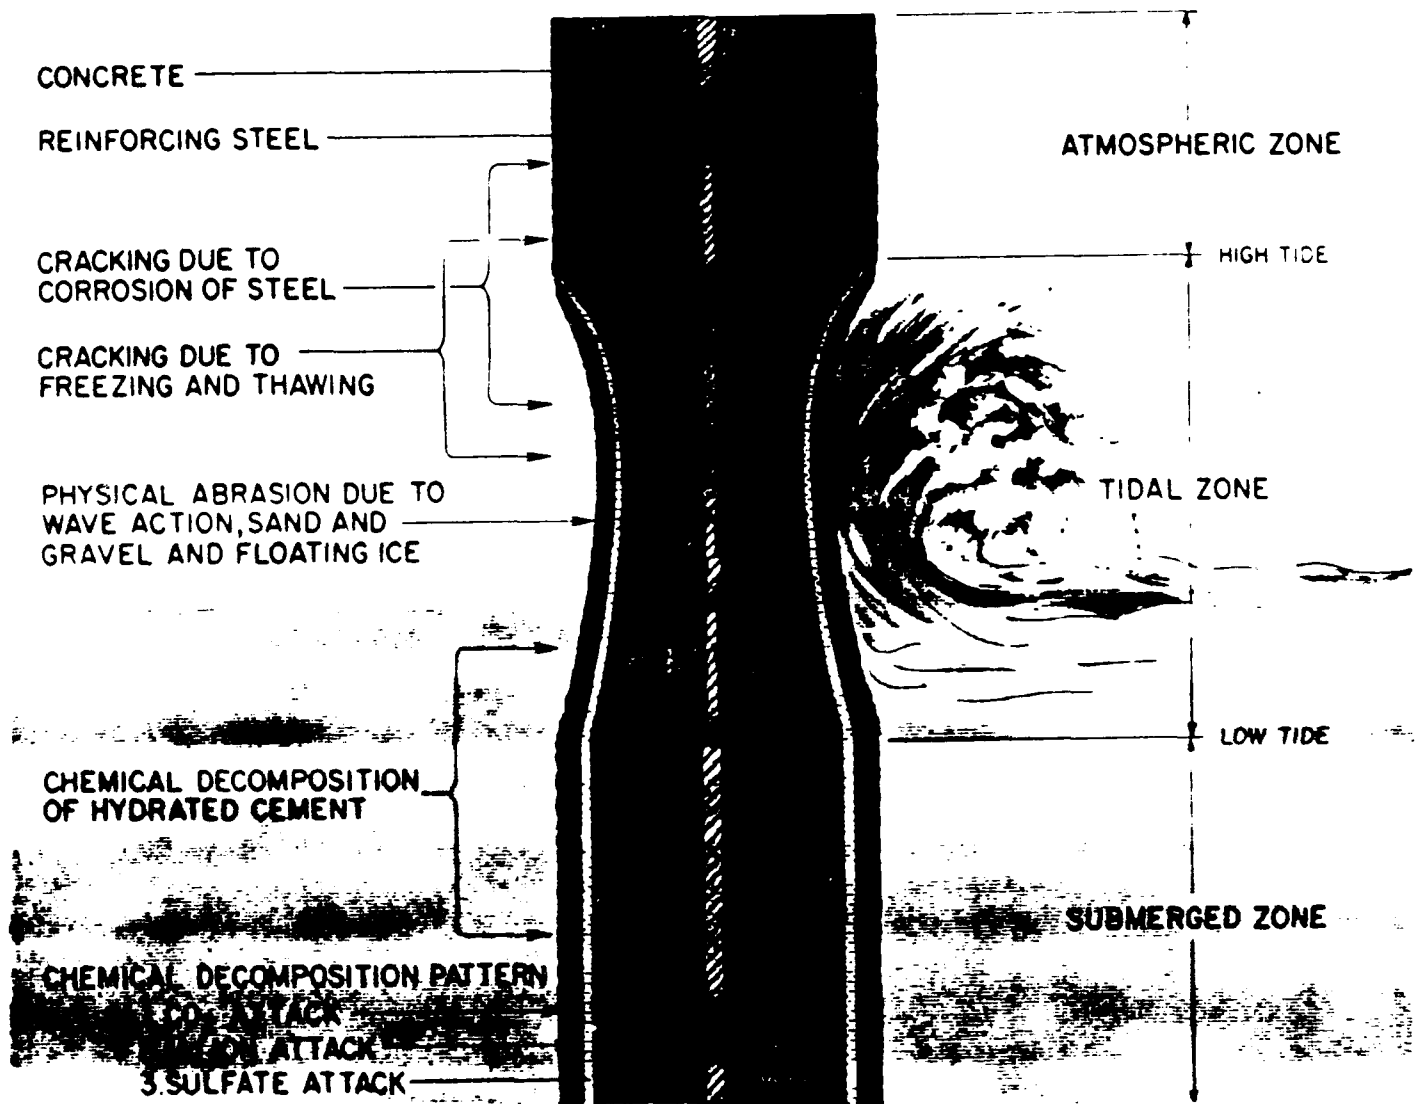
**FIGURE II.1 Processes responsible for deterioration of reinforced concrete exposed to the marine environment**

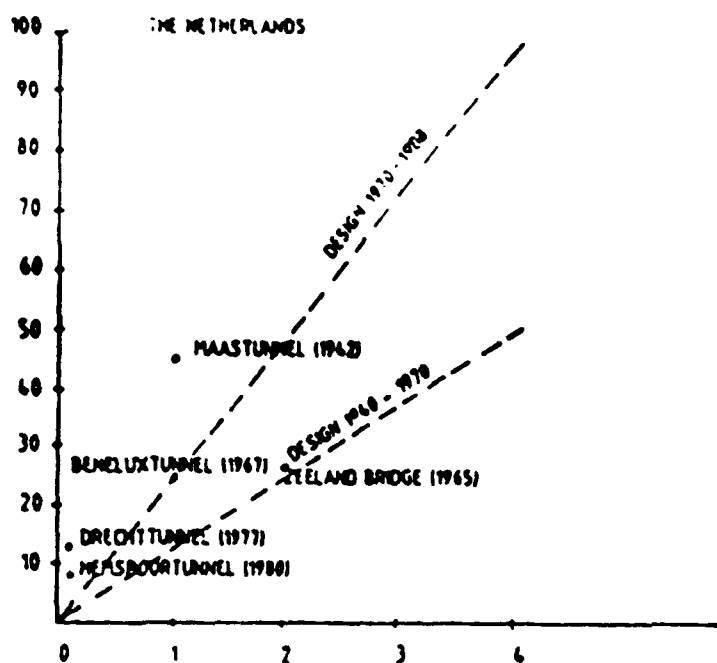
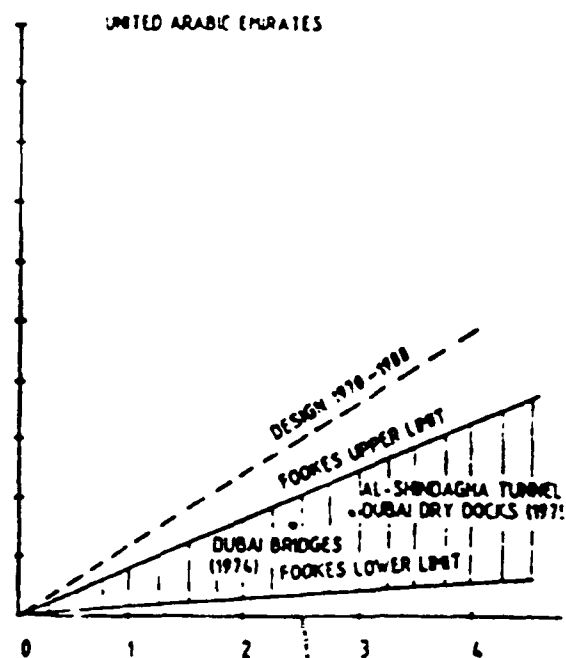
CLASS	0	1	2	3	4
REINFORCED	NO DEFECTS	RUST STAINING AND MINOR CRACKING	ONSET OF CORROSION CRACKING	MODERATELY SEVERE CRACKING SOME SPALLING	SEVERE CRACKING AND SPALLING TERMINAL CONDITION
MASS	NO DEFECTS	MINOR SURFACE WEATHERING OR POP-OUTS OR CRACKS	MODERATE SURFACE WEATHERING ISOLATED CRACK	MODERATE TO SEVERE WEATHERING OR INTERCONNECTED CRACKS	SEVERE LOSS OF CONCRETE SURFACE DISRUPTIVE CRACKING TERMINAL CONDITION

**FIGURE II.2 Effects of heat as a deteriorating factor for  
concrete exposed to the marine environment**

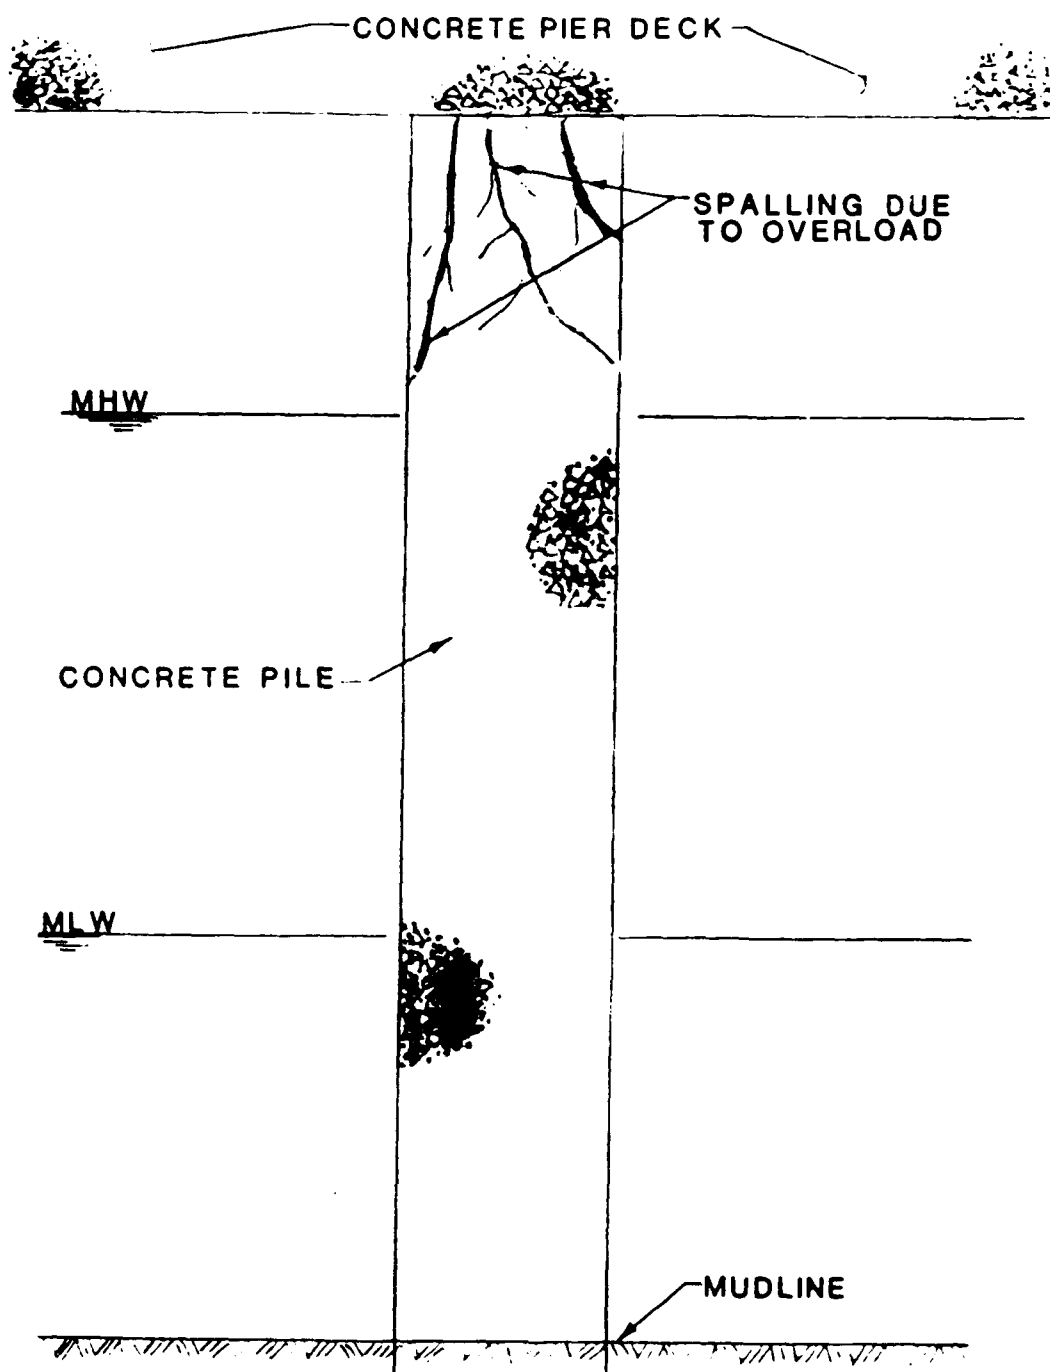
**FIGURE II.3 Deterioration of a reinforced concrete pile subjected to overloading**

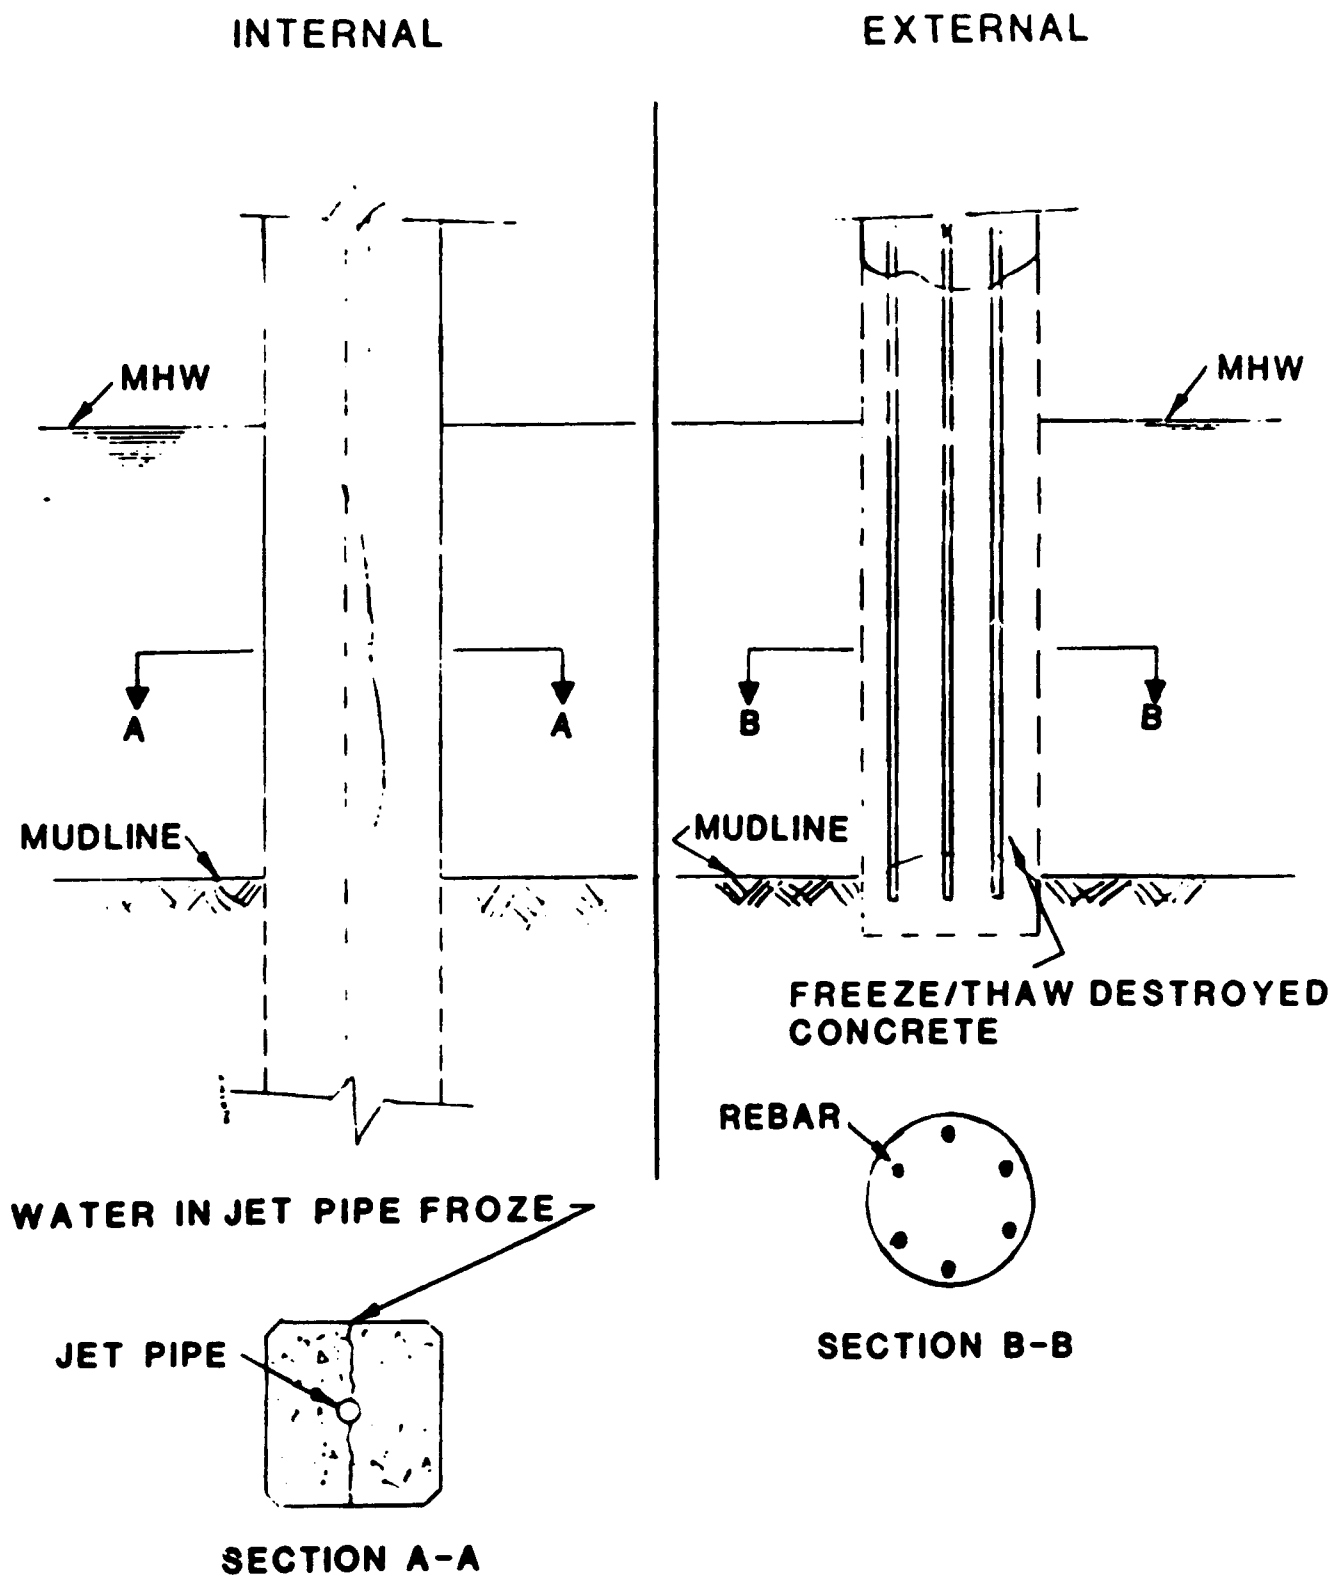
FIGURE II.4 Deterioration of reinforced concrete piles due to freeze/thaw cycle

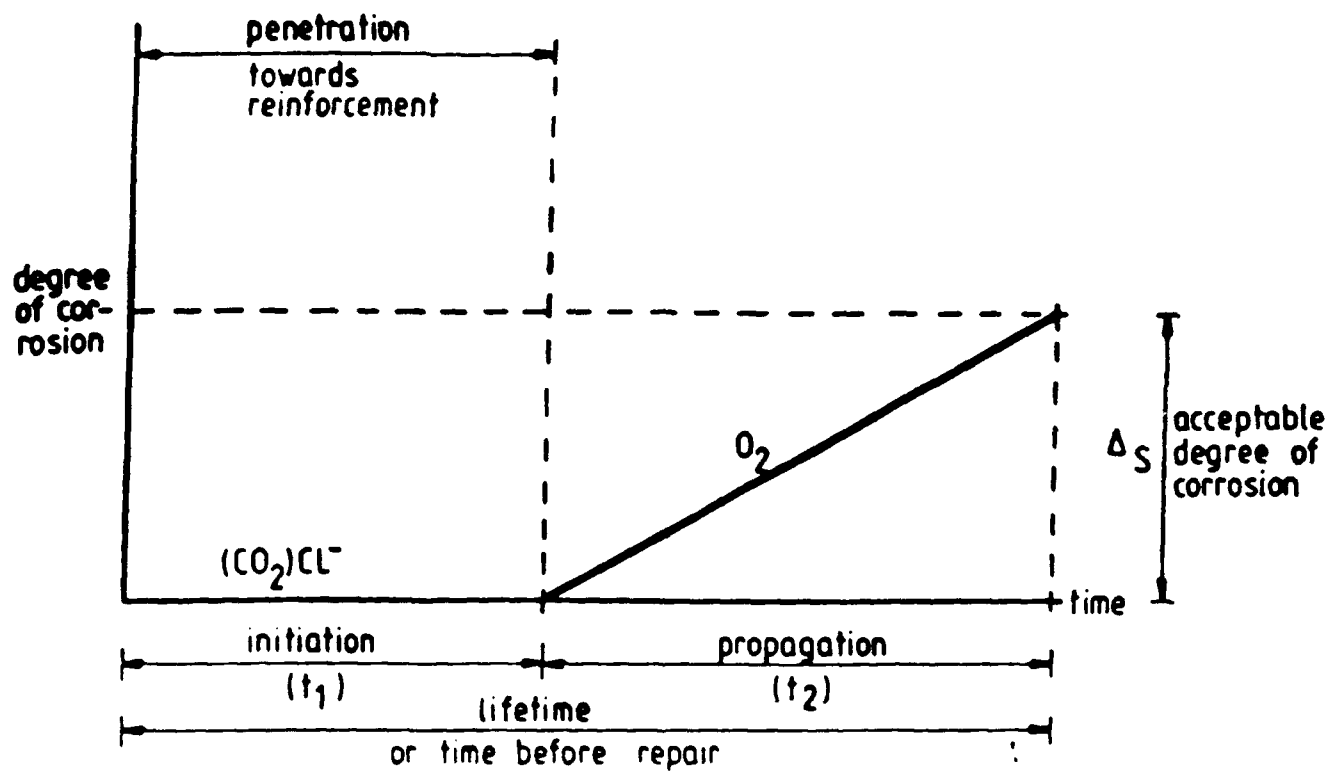
FIGURE II.6 Schematic representation of the corrosion process of steel in reinforced concrete

Loss of passivation  
by chloride  
rusting, and eventual  
spalling of concrete

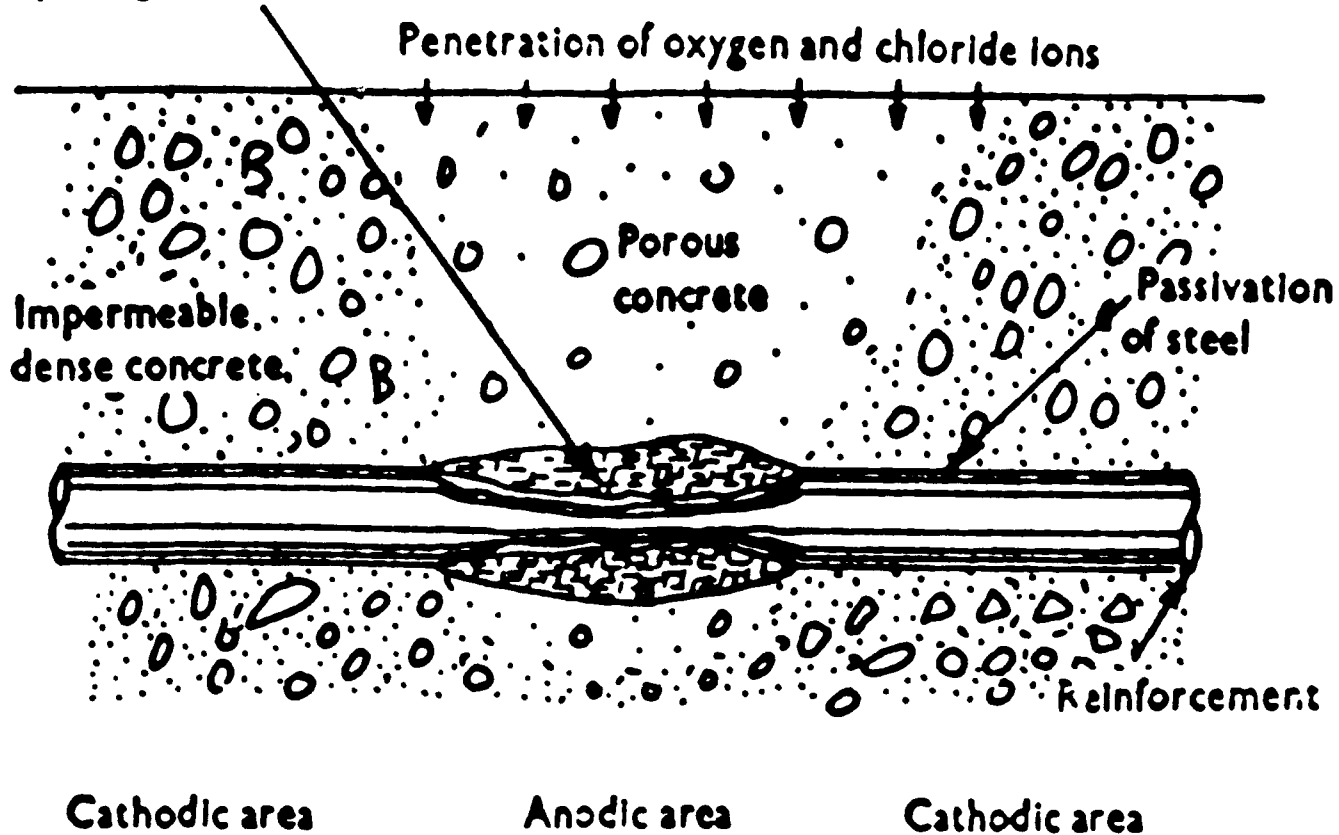
FIGURE II.7 Typical corrosion cell

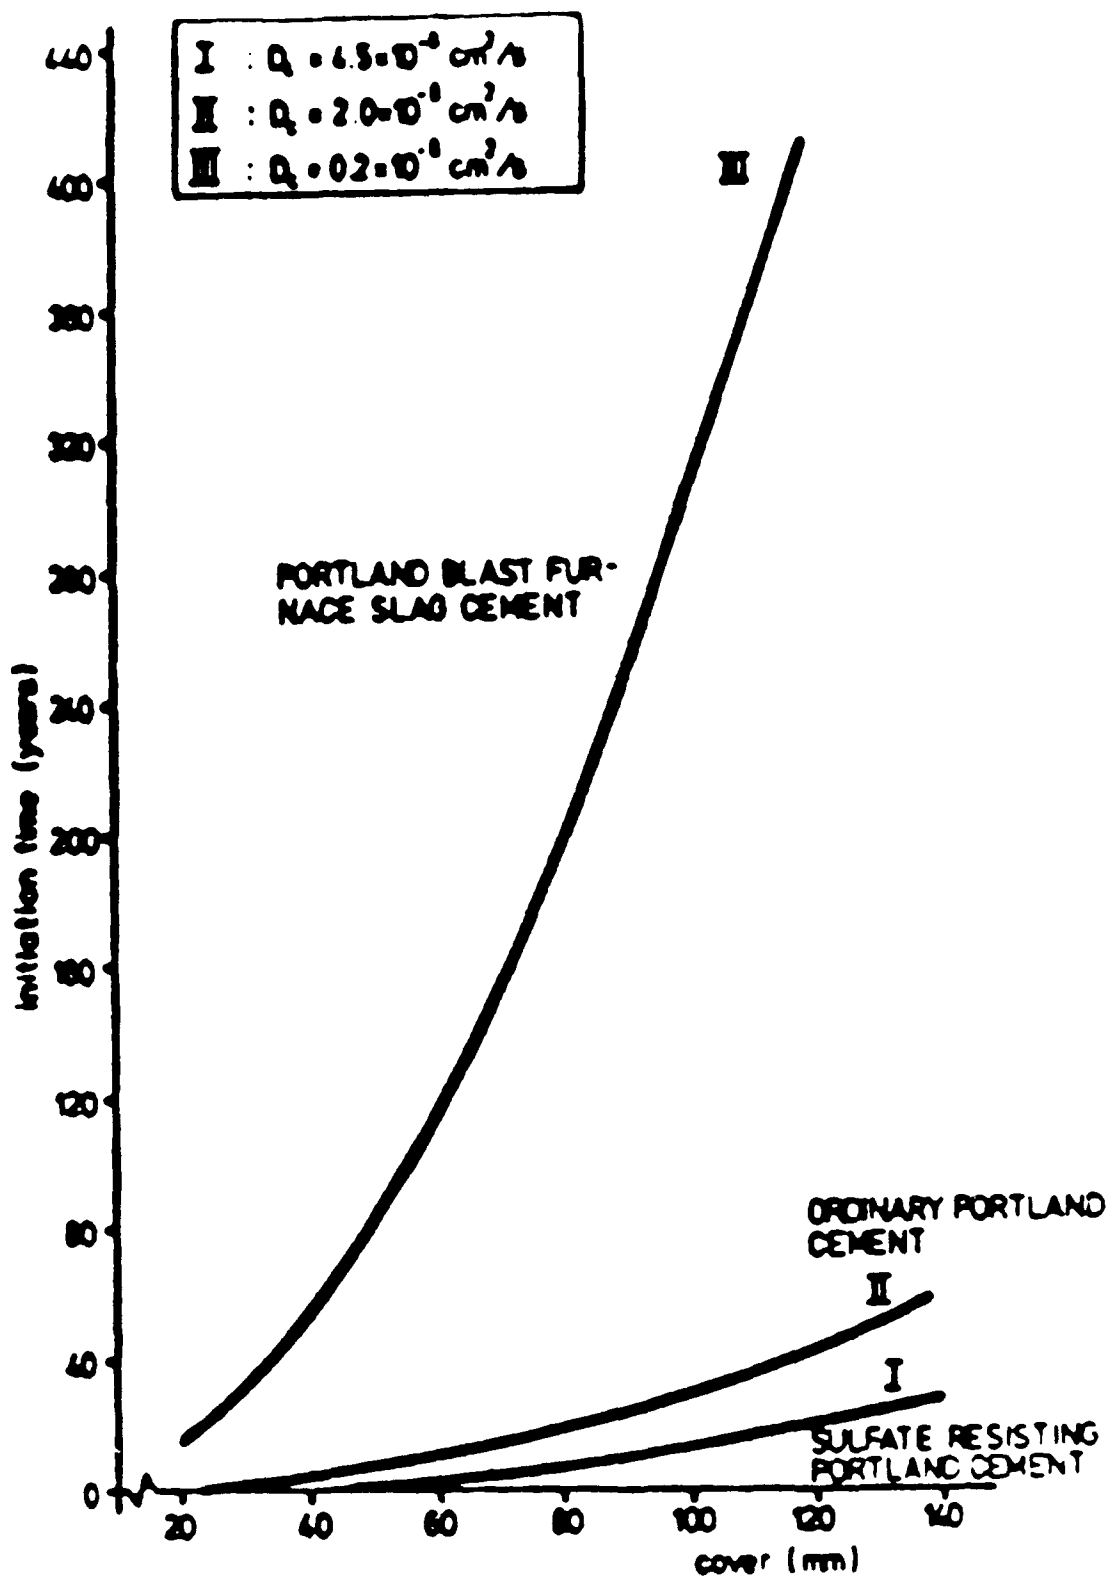
FIGURE II.8 Time for initiation of the corrosion process for three different types of cement

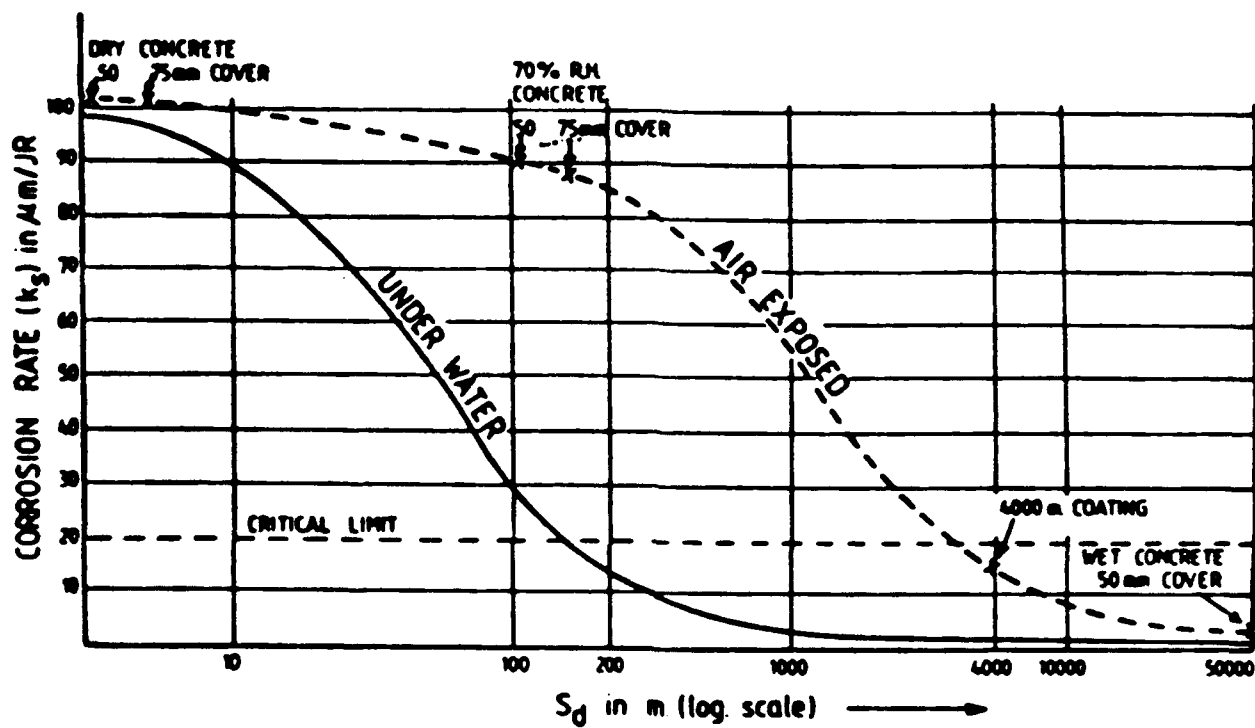
FIGURE II.9 Corrosion rate as a function of the oxygen diffusion resistance

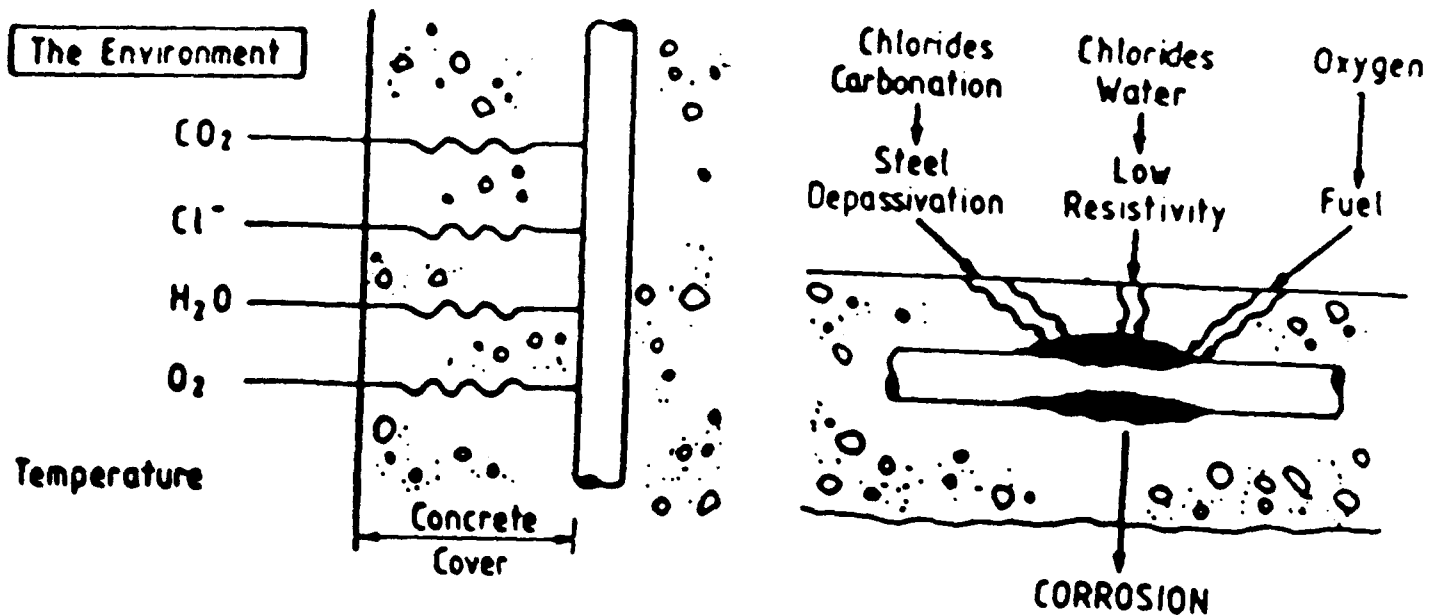
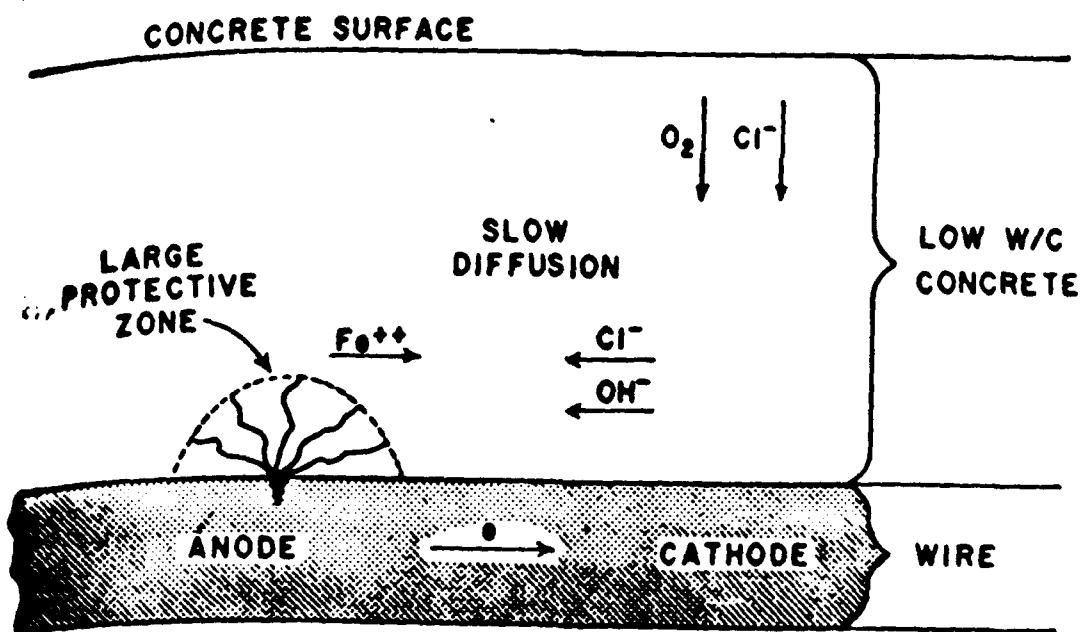
FIGURE II.10 Mechanisms of corrosion

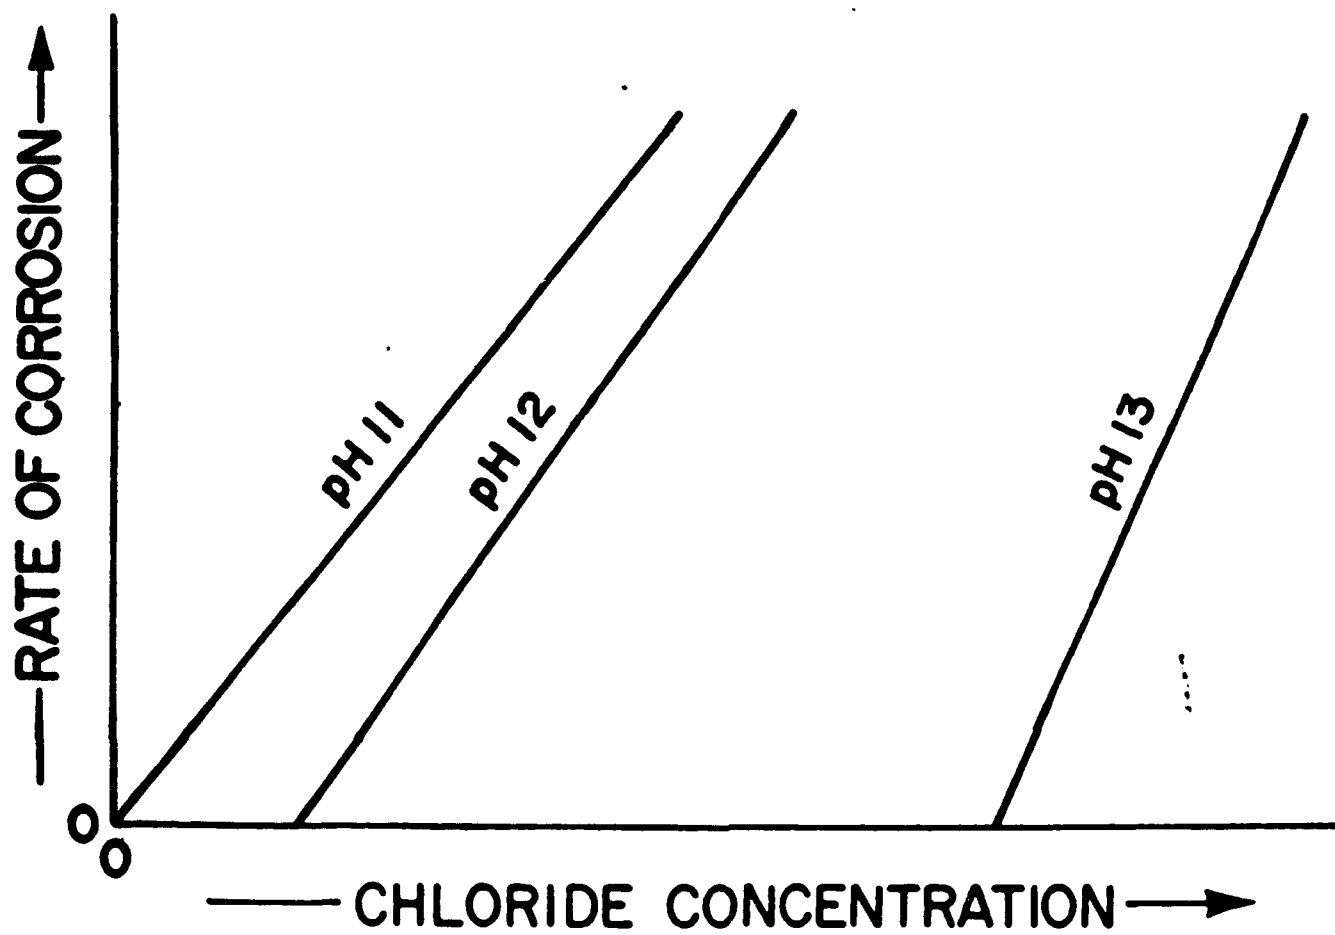
FIGURE II.11 Relationship between chloride concentration and rate of corrosion

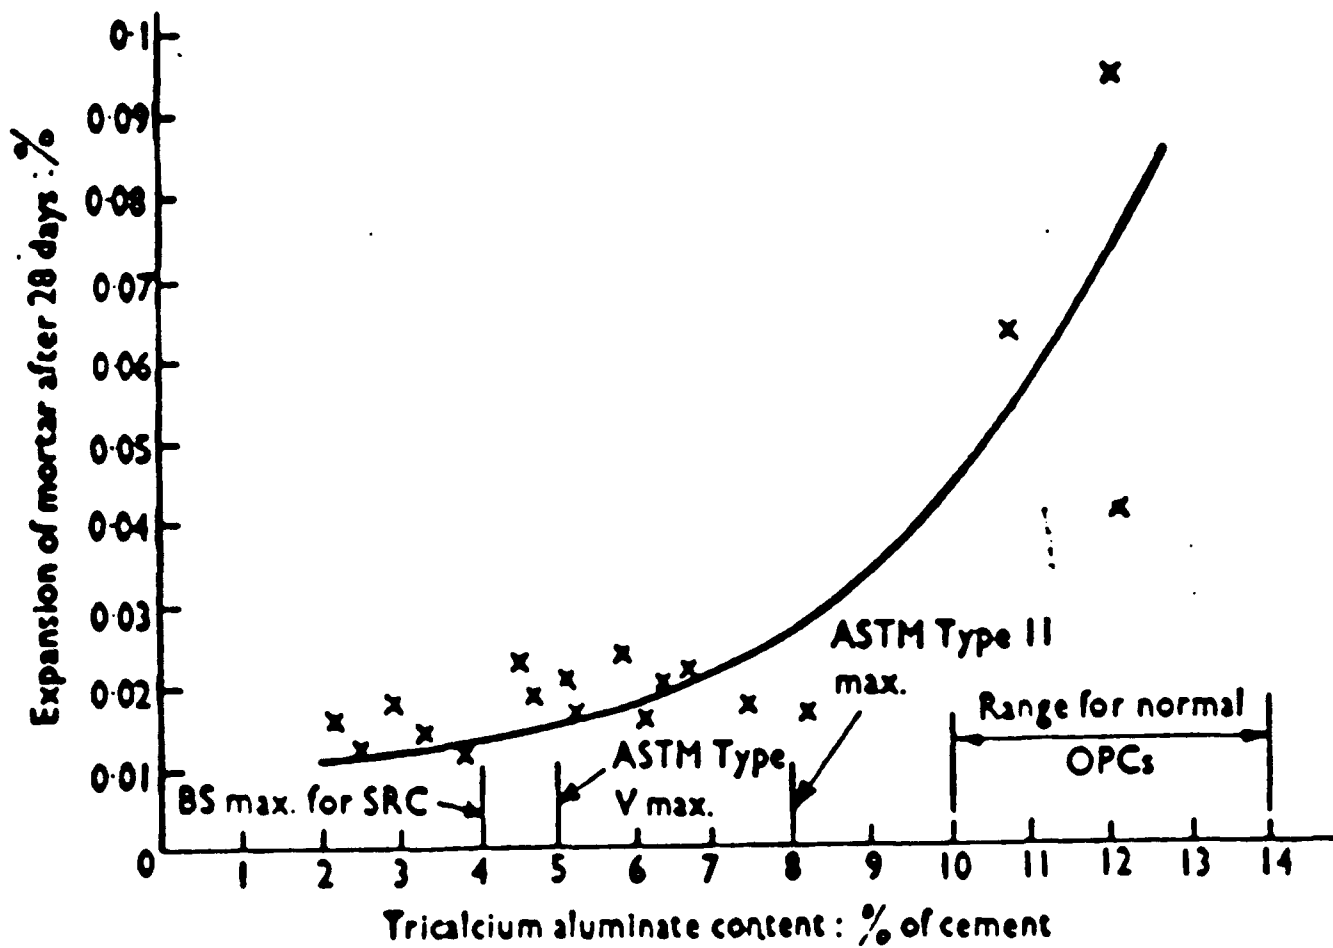
FIGURE II.12 Effect of tricalcium aluminate on sulfate resistance of Portland cements

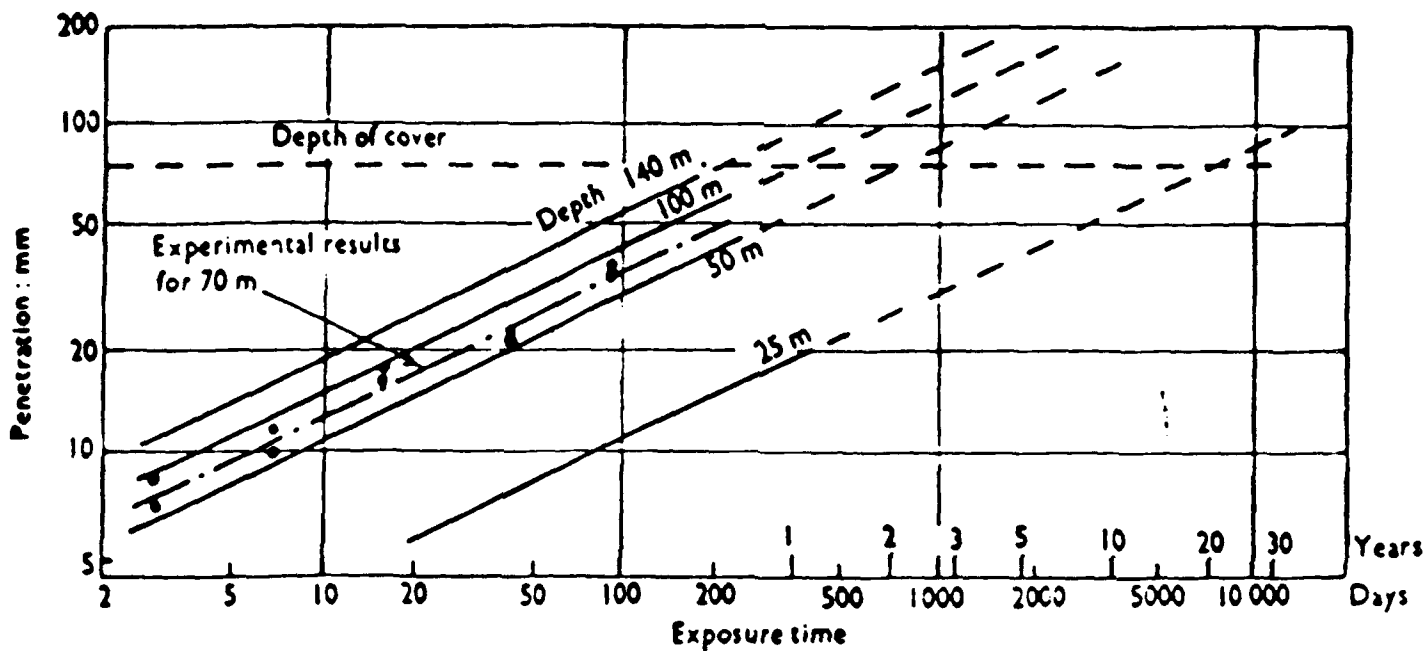
FIGURE II.13 Penetration rates of seawater into concrete at various depths

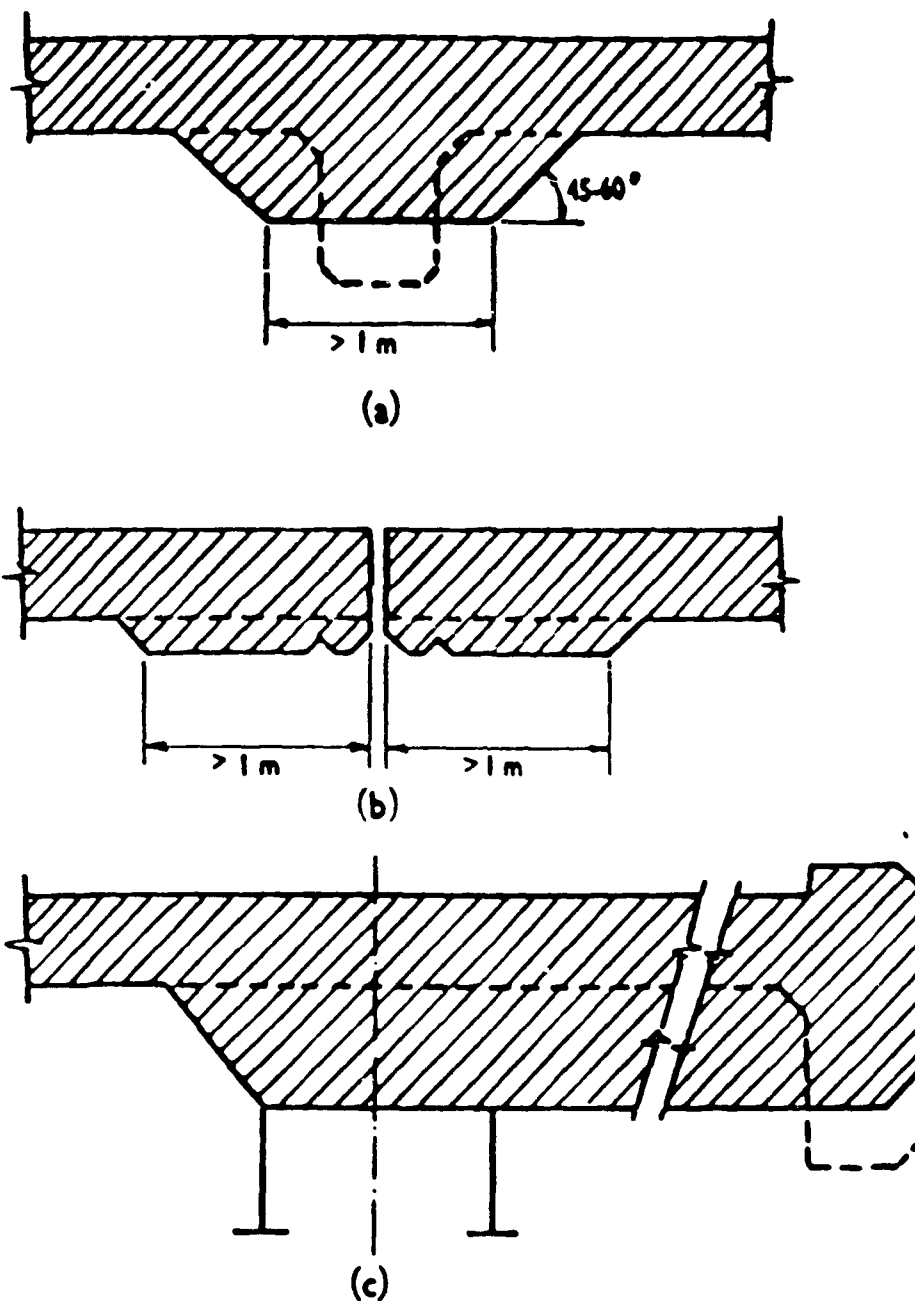
FIGURE II.14 Recommended shapes for structural members

Traditional designs are represented by dotted lines

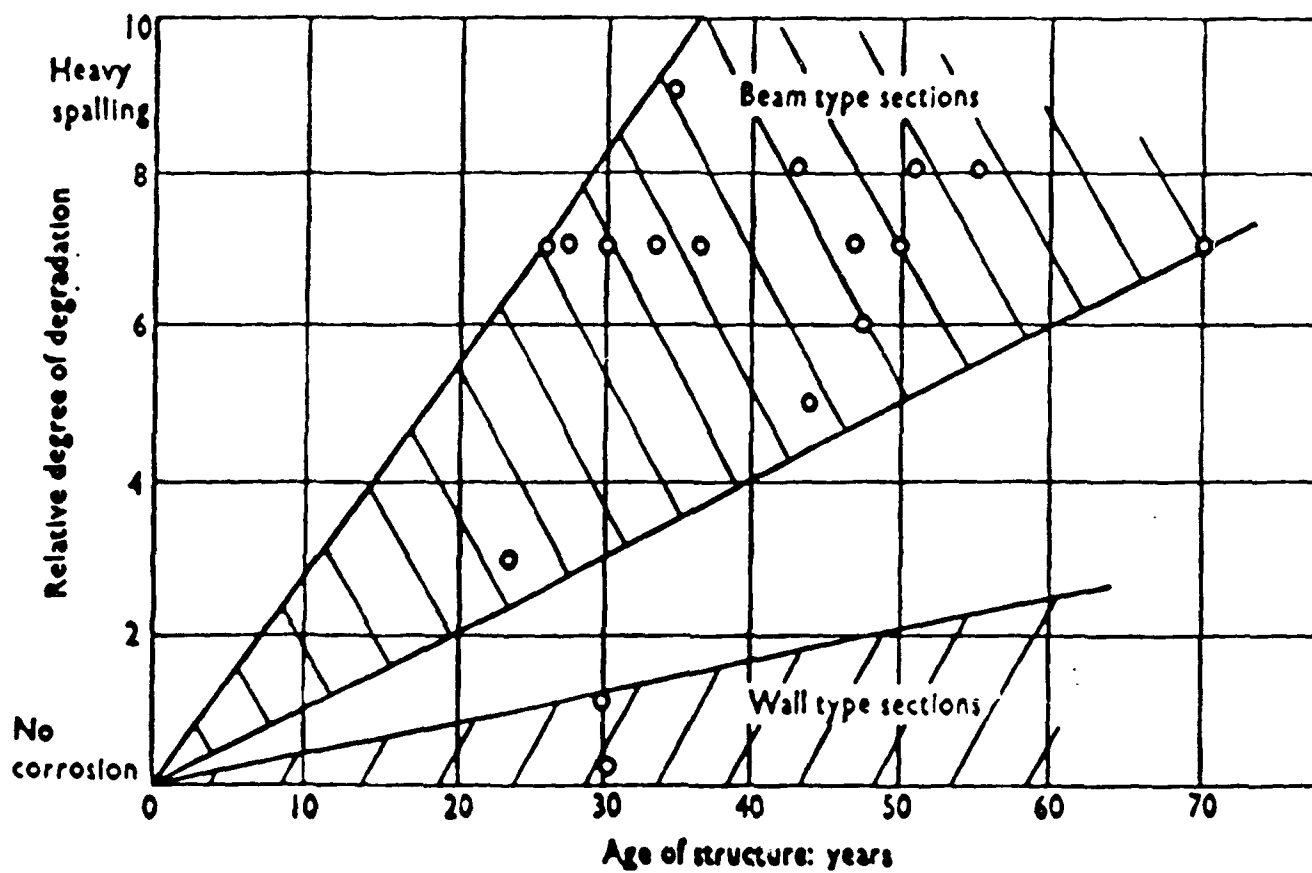
FIGURE II.15 Shape of structural member effects upon the degree of degradation verses age of structure

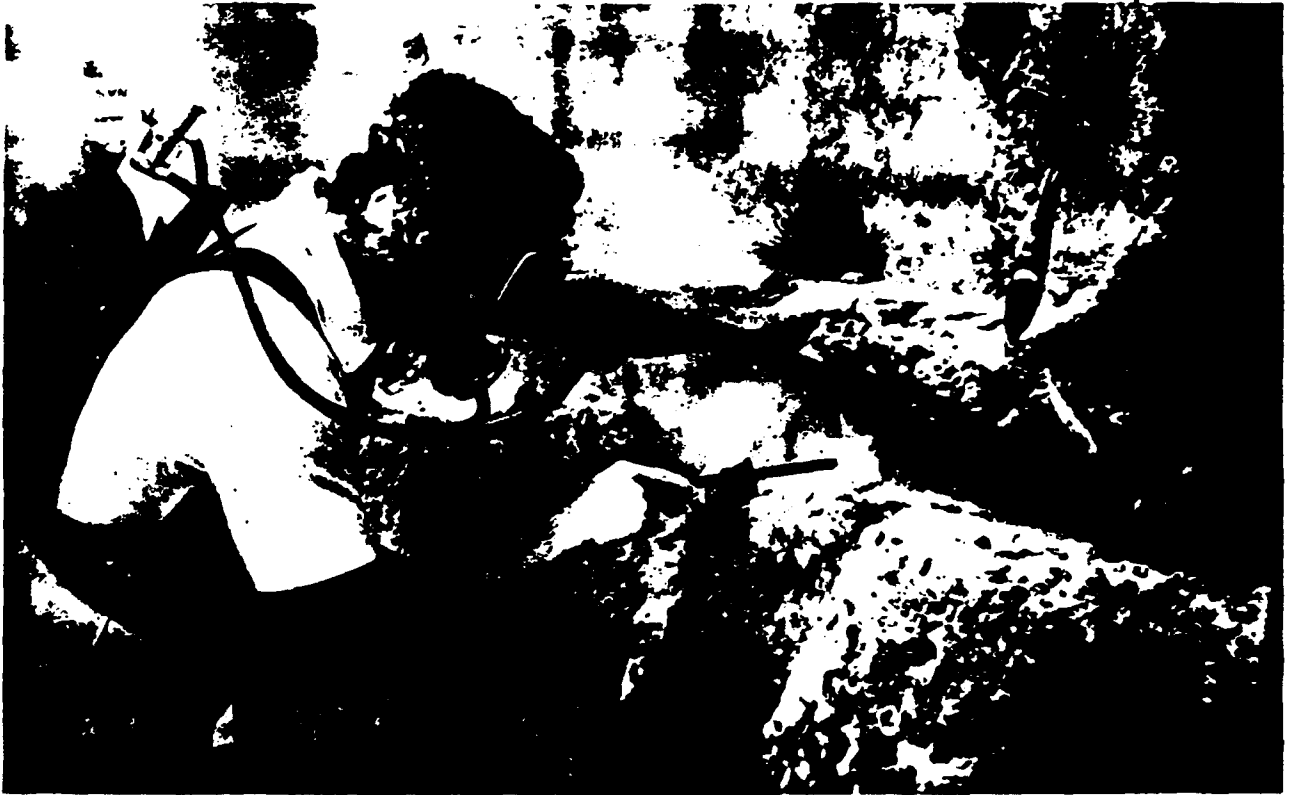
Figure III.2 Diver Engaged in Underwater Visual Inspection [47]

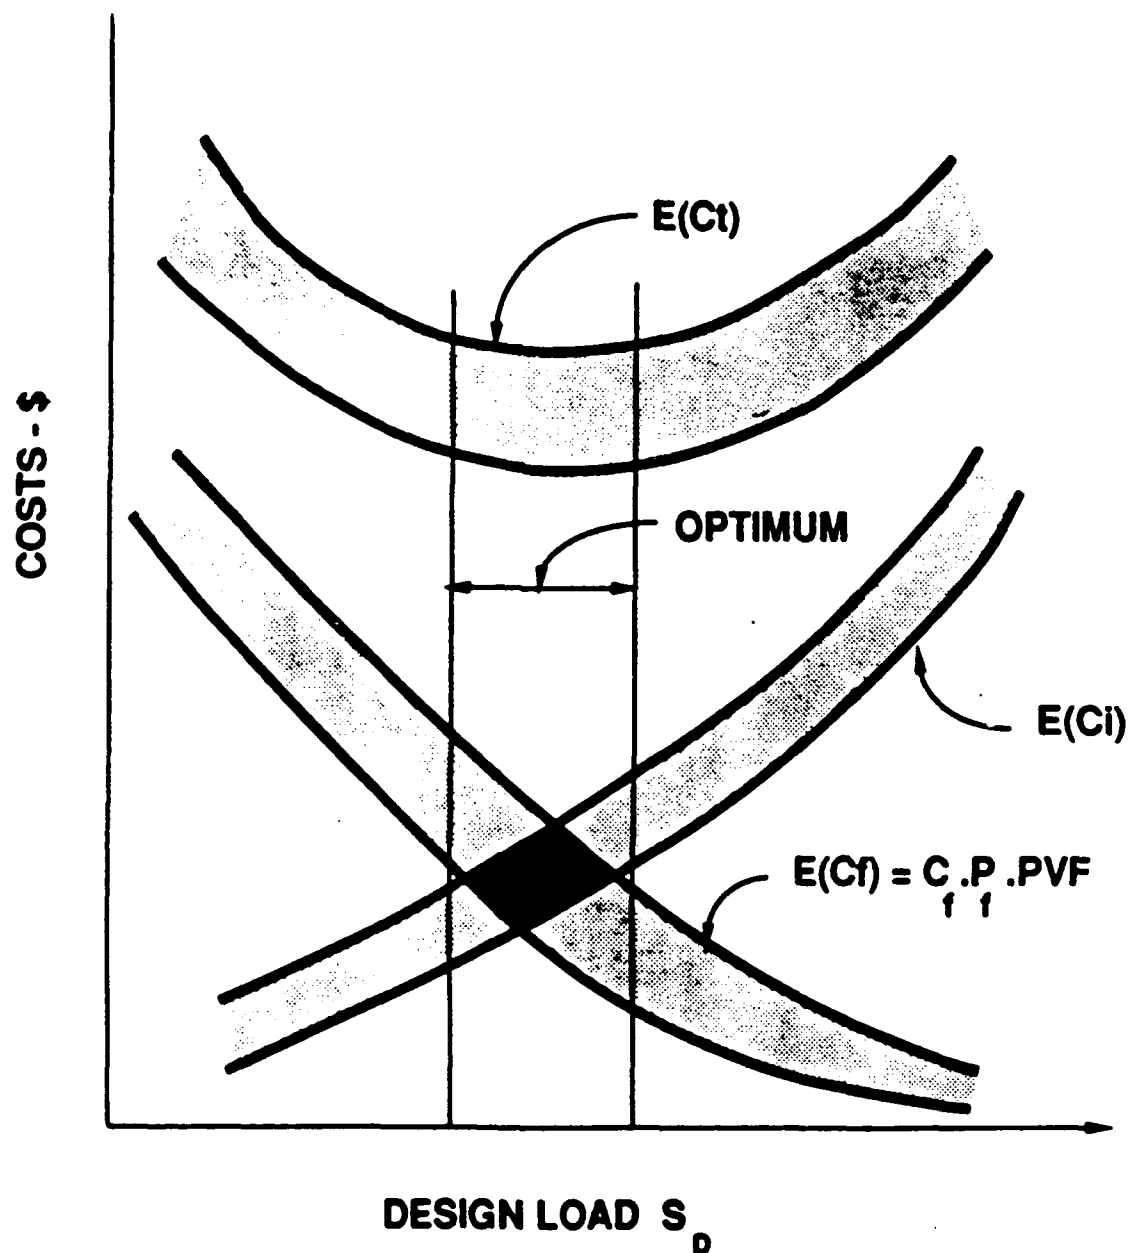
Figure III.13 Optimization of Total Initial and Future Costs

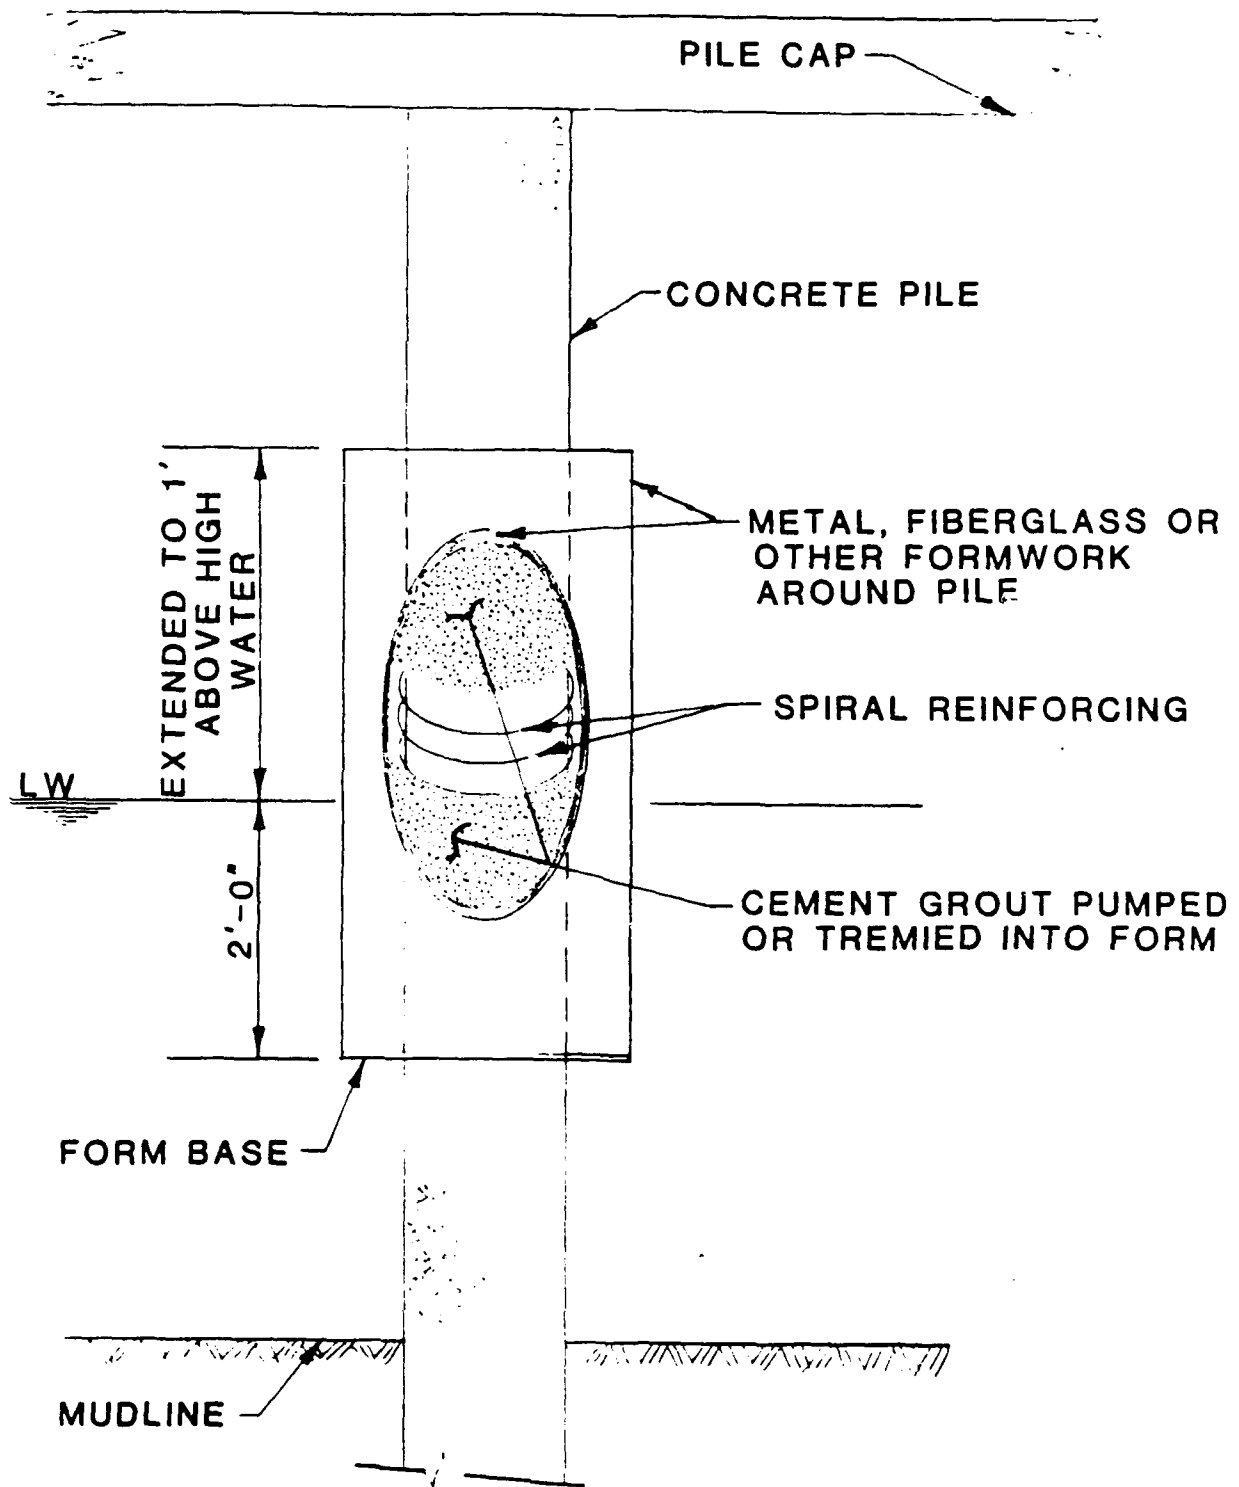
FIGURE IV.7 Typical View of Concrete Encasement Method [26]
